## ► Water Conservation From Reduced Tillage And Land Forming

**Presented by Dr. Garry N. McCauley**

*Rice Agronomist, Texas A&M University*

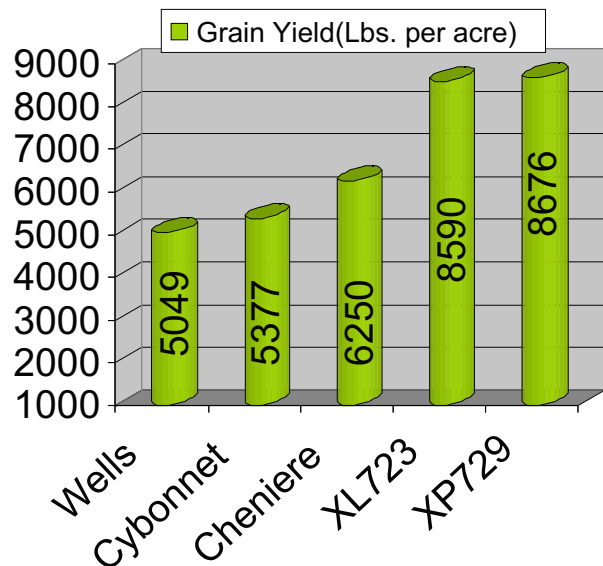
in Arkansas county, Arkansas from 2005-2006. Hybrids have a 3,075 lb raw yield advantage over the conventional varieties on bedded trials.
